RISK WATCH

Fender damage when berthing

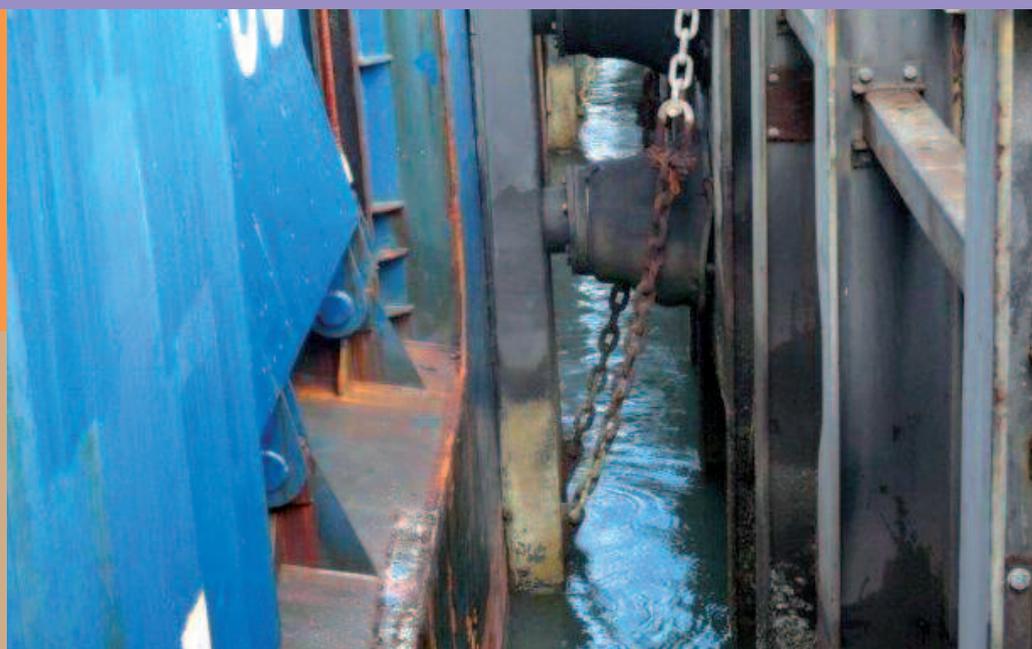
In a recent case handled by the Club, a car carrier completed berthing about 15 minutes before low tide. The ship was positioned in accordance with the instructions of the port personnel but it seems that they focussed on making sure that the ship was positioned in their own preferred location for setting down the ship's stern side ramp on the berth rather than taking into account the position of a fender. Nobody on the ship noticed that the

tide was so low that the base of the stern side ramp was directly below a fender and that there was a risk of the ship's hull becoming caught on the fender when the tide began to rise. Several hours later, the inevitable happened. The ship's crew managed to adjust the mooring lines and shift the ship slightly along the berth but it was too late and the fender had by then been partially ripped away from the berth wall.

The master and crew should be aware that they are almost always legally responsible for the handling and berthing position of the ship, irrespective of the pilot or shore personnel giving guidance or instructions.

A risk assessment should be considered to make sure that the master and crew are aware of any undesirable locations in relation to port property, such as where fenders might

become damaged by the ship, either during the actual berthing or with the changing tide. The master should receive continual observations and assistance from ship's officers at the fore and aft stations during the berthing manoeuvre. A responsible officer should also be tasked to verify that the final position is safe in respect of potential protrusions on the ship or the berth before 'shutting down'.
