RISK WATCH

Collision

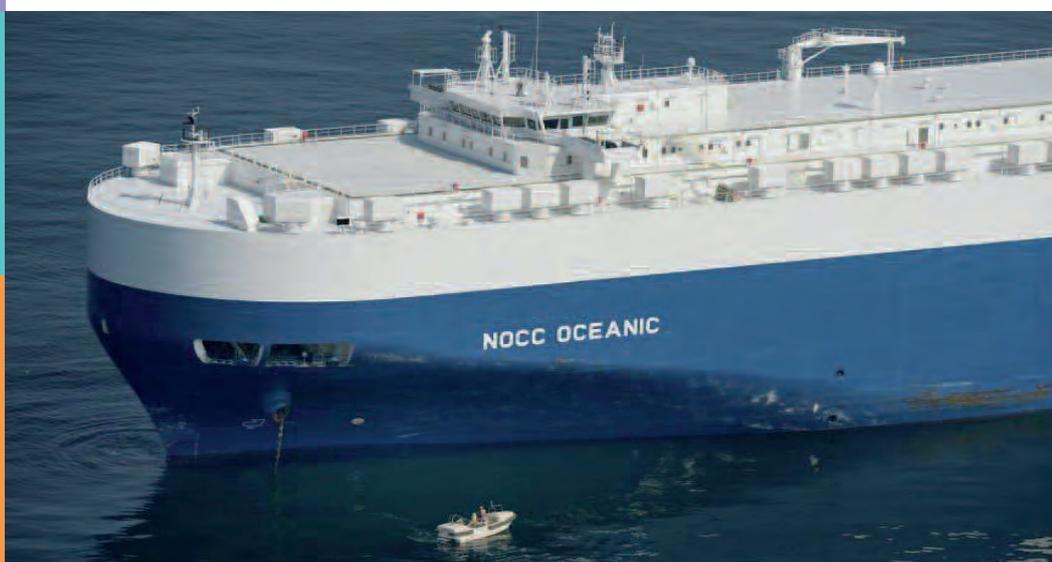
The use of sound signals and keeping a proper look out could have prevented this collision between a car carrier and a fishing vessel.

At 09:33 *NOCC OCEANIC* entered a heavy squall. Visibility deteriorated such that the bow mast (approximately 30m forward of the bridge) could barely be seen. Because he could see so little out of the window, the third officer moved to the radar to continue his look out. He could see no other ships in the vicinity, either by radar or by AIS data (which was configured to display on the radar). He did not call the master to advise him that the range of visibility had changed and he maintained the same course and speed without using sound signals as appropriate in restricted visibility.

visibility caused by rainfall) or by radar (due to rain clutter). He had not properly utilised the anti clutter settings on the radar equipment, which may have improved radar detection (although it is not known to what degree). It is also not clear whether the S-band or X-band radar was in use, S-band being better able to detect targets through rain clutter.

The deckhand of *YUJIN MARU No. 7* did not notice *NOCC OCEANIC* because he kept watch by sight in a position where there was a blind area caused by a wall in the watch room. He did not see *NOCC OCEANIC* approaching on a bearing of 83 degrees on the starboard bow. He was not permitted by the master to adjust the settings of the radar himself.

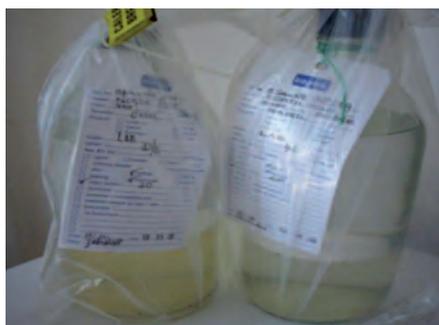
Properly prepared sample bottles.

Sample bottles and seal numbers should be noted and a sample log kept up to date. All bottles should be labelled, sealed, witnessed and countersigned. Samples should be stored securely and for a length of time which complies with company procedures.
