Fatal crush incident

BACKGROUND

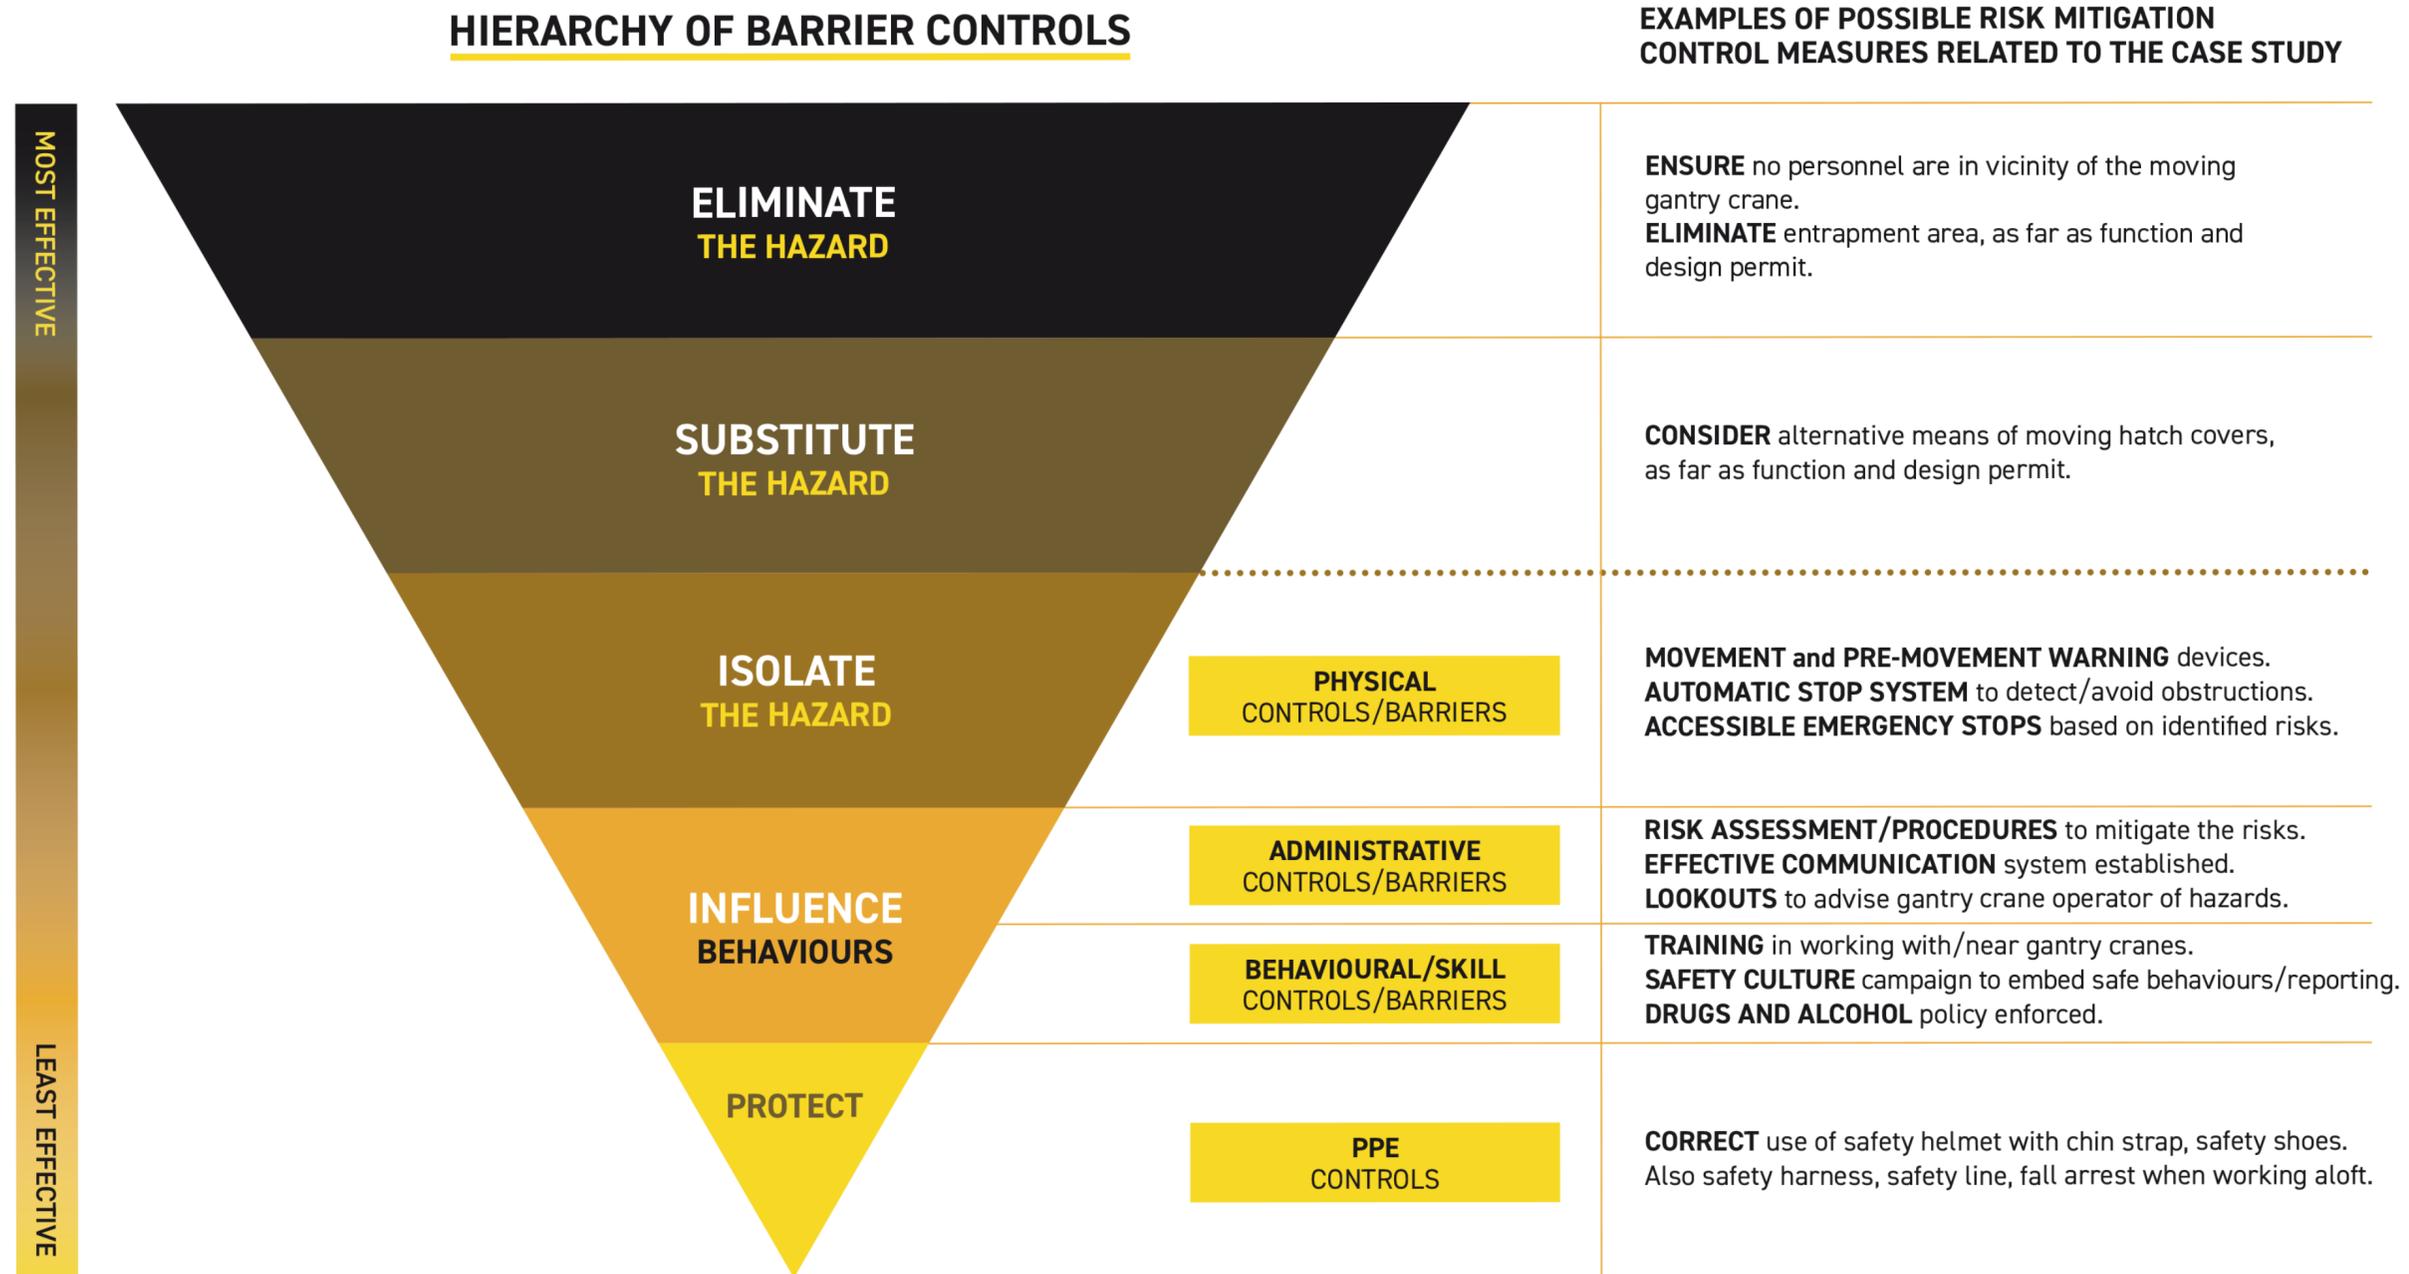
The suggested barriers/controls above are provided to help generate reflective discussions, and should not be considered as conclusive/definitive or comprehensive for the provided case study. The risk and control measures relating to any similar scenario or activity must always be appropriately assessed based on the specific onboard arrangement and circumstances.
