CARGO FUMIGANT POISONING LEADING TO A FATALITY

A SMALL SHIP WAS CHARTERED TO CARRY A CARGO OF CORN ON A SHORT HAUL VOYAGE IN EUROPE. ON COMPLETION OF LOADING, ALUMINIUM PHOSPHIDE WAS PLACED IN THE HOLDS TO FUMIGATE THE CARGO IN TRANSIT. ON THE SECOND DAY OF THE VOYAGE, WHILE THE SHIP WAS EXPERIENCING HEAVY WEATHER, HYDROGEN PHOSPHIDE GAS (PH₃) ENTERED THE ACCOMMODATION AREA VIA A HYDRAULIC ROOM. THE FUMIGANT WAS NOT DETECTED IN TIME TO AVERT LETHAL LEVELS OF EXPOSURE. SEVERAL MEMBERS OF THE CREW WERE OVERCOME WITH ONE CREW MEMBER DYING AND THREE OTHERS HAVING TO BE EVACUATED.

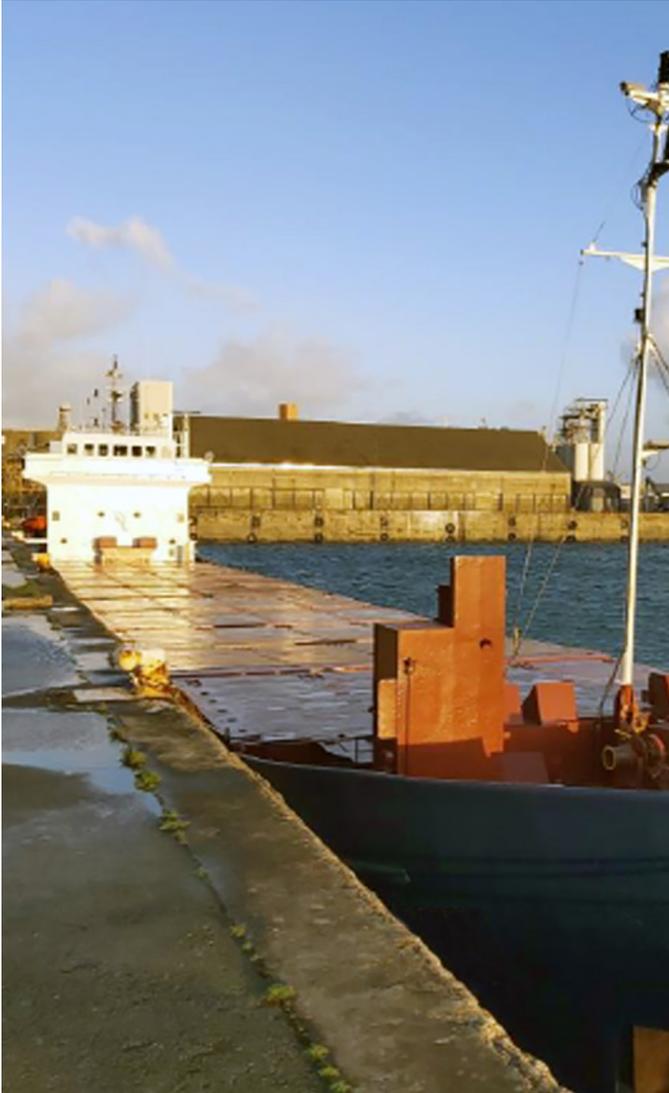
It was not until around 1800 when the master became aware that at least three of the crew were unwell and the possibility of fumigation poisoning was raised. The information provided by the fumigation company was then re-checked and, the master tested the atmosphere in the accommodation and confirmed the presence of the fumigant gas (PH3).

At 1833, the second officer (2/O) phoned local authorities to report the presence of the fumigant in the accommodation and requested assistance. The crew were then moved to the ship's office and master's cabin where windows could be opened to increase the flow of fresh air. Sometime before 1900, the able bodied seaman/cook (AB/Cook) returned to his cabin for an unknown reason, which was unnoticed.

At 2019, a rescue helicopter reached the ship and a winchman was lowered on to the deck. However, the helicopter had to return to base without the crew affected and the winchman due to the weather conditions combined with a technical issue. The ship then re-routed to Brest in France.

At 2059, the winchman reported to shore that three members of the crew were in a serious condition and that the AB/Cook had been found dead in his cabin.
