INJURY AND EXTENSIVE DAMAGE DUE TO CABIN FIRE

A FIRE OCCURRED ONBOARD A 2,565 GT GENERAL CARGO SHIP, CAUSING EXTENSIVE DAMAGE AND INJURING ONE CREW MEMBER. FORTUNATELY, NO LIVES WERE LOST.

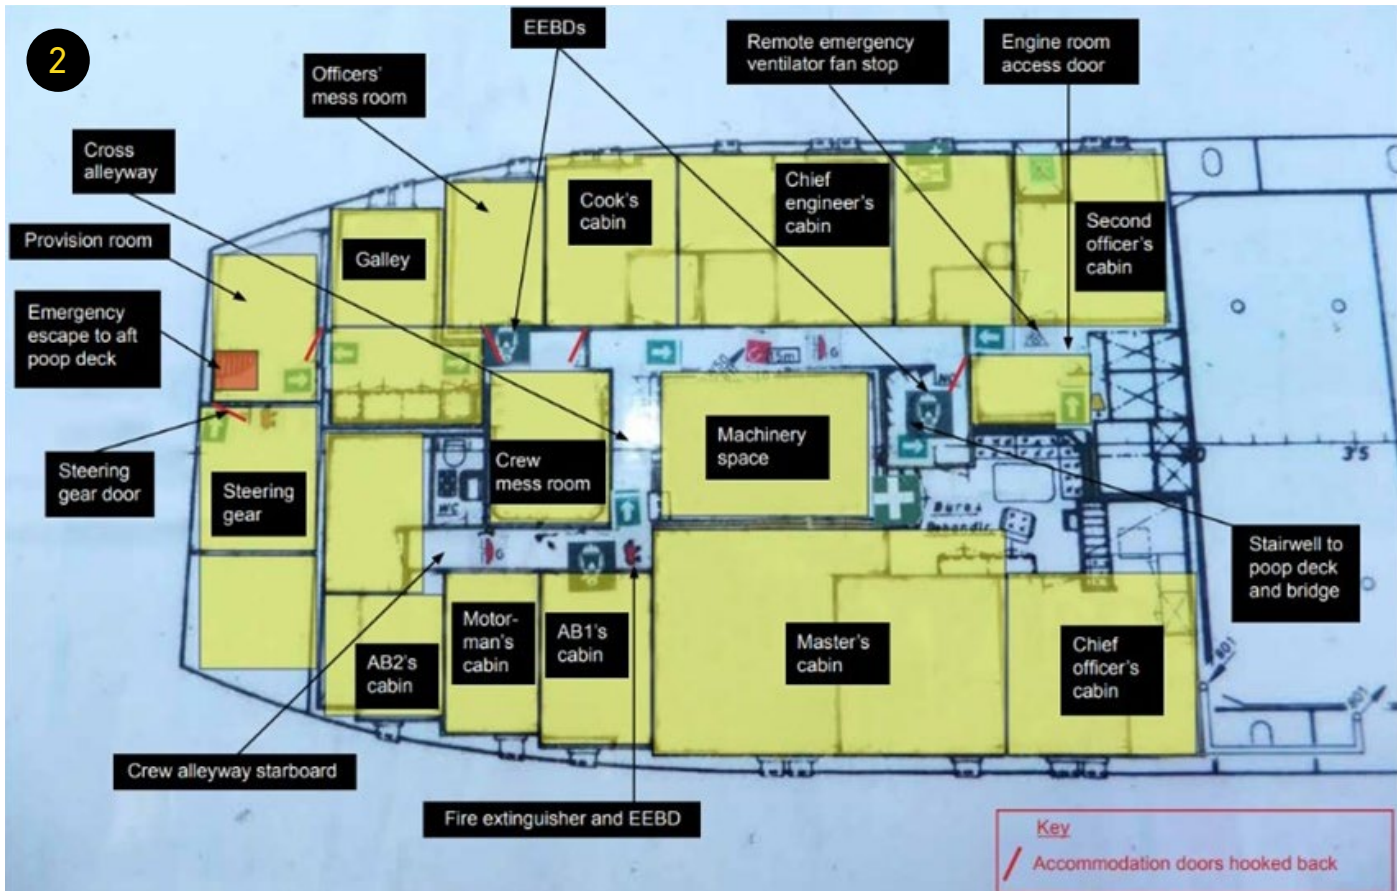
FIGURE 2 DECK 2 ACCOMMODATION LAYOUT
SOURCE MARINE ACCIDENT INVESTIGATION BRANCH - GOV.UK: ACCIDENT INVESTIGATION REPORT 18/2014²

During a layover in Gibraltar for bunkering and minor repairs, the crew had the opportunity to go ashore. One of the crew members (AB2) consumed alcohol before returning to the ship, which then resumed its journey to Belfast. Later that evening, AB2 retired to his cabin located on the starboard aft side of Deck 2.

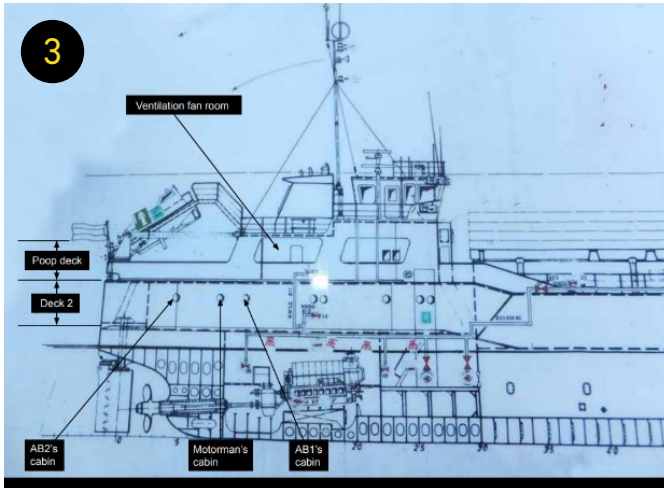
FIGURE 3 VESSEL AFT SECTION PROFILE

With the chief officer's (C/O) approval, the 2/O directed the crew to set up a stage along the starboard side of the ship near AB2's cabin porthole. From here, AB1, equipped with various safety gear, managed to direct a fire hose into AB2's cabin through the porthole. Whilst the master coordinated this from the bridge, receiving updates on the firefighting efforts, smoke and flames were seen from AB1's cabin porthole. As the crew adjusted the stage along the starboard side, they observed a red glow and closed conditions in the motorman's cabin. Due to intense heat from AB1's cabin, multiple attempts were required to effectively aim the fire hose. Further concerns arose, around 0600 when the C/E noticed excessive water draining into the engine room, leading to the decision to stop the fire/ballast pump and postpone further inspections until daylight. Additionally, a power outage resulted in steering gear failure.
