ALLISION WITH PIER AND DRY DOCK BY CAR CARRIER

INCIDENT CASE STUDY

No.28 | SEPTEMBER 2025

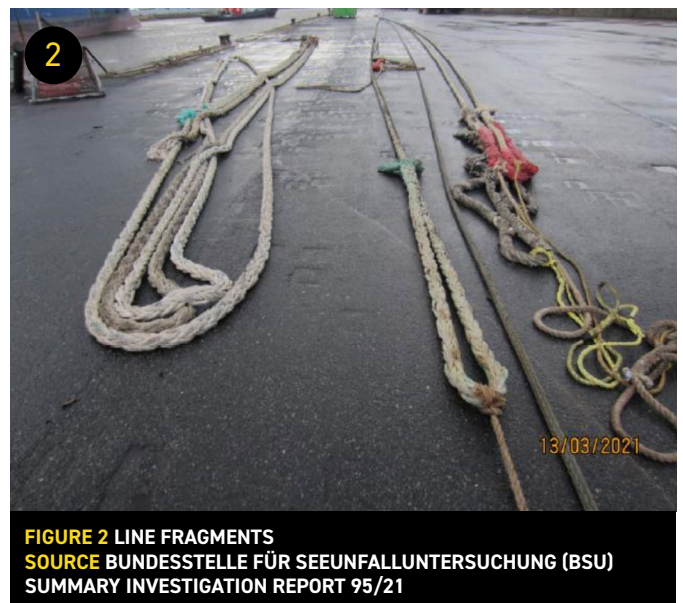
MOORING LINES CONDITION

The investigation report identified that 12 of the 14 mooring ropes in use were not in adequate condition and should not have been employed. According to the investigation report, the ship's mooring equipment was designed to withstand wind forces of up to 60 kts (Bf 11). Therefore, the poor condition of the mooring lines was identified as the main cause of the incident. The ship operator's Safety Management System (SMS) required deck officers to monitor mooring lines during berthing and manoeuvring. However, this procedure was clearly insufficient, as it did not ensure effective mooring line inspection and line management.

This inadequacy is addressed in the SOLAS amendments to Chapter II-1, Part A-1, Regulation 3-8, point 9, which require companies to develop procedures for mooring operations, inspection, and maintenance of mooring equipment, including lines. These procedures must specify criteria for the replacement, end-to-end change, and retirement of mooring lines and tails, considering manufacturers' recommendations.
