# RISK WATCH

## Navigation and seamanship

- 1 Charts: the importance of keeping charts up to date
- 2 Port of Chittagong: risk of collisions
- 3 Piracy update

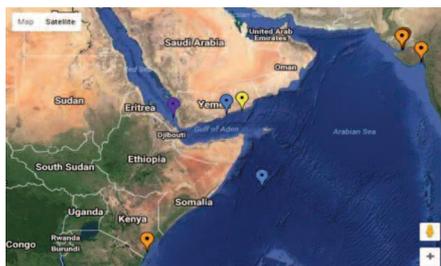
Somalia/Gulf of Aden

– Suspicious vessel
