AS PART OF THE CASE STUDY MATERIAL, THE FOLLOWING COMMENTARY PROVIDES FURTHER ANALYSIS OF SOME OF THE KEY ISSUES TO SUPPORT REFLECTIVE LEARNING.

## SCAFFOLDING FALL CAUSES SERIOUS INJURIES

**THE USE OF MOBILE SCAFFOLD TOWERS HAS BECOME A RELATIVELY COMMON PRACTICE ON BOARD SHIPS, IN PARTICULAR ON BULK CARRIERS.** HOWEVER, THEIR USE HAS ALSO RESULTED IN A NUMBER OF SERIOUS INCIDENTS. IN THIS PARTICULAR CASE, THE DECISION BY THE TWO CREW MEMBERS TO REMAIN ON THE SCAFFOLDING WHILE IT WAS BEING REPOSITIONED LED TO THE TOWER BECOMING TOP-HEAVY AND TOPPLING.

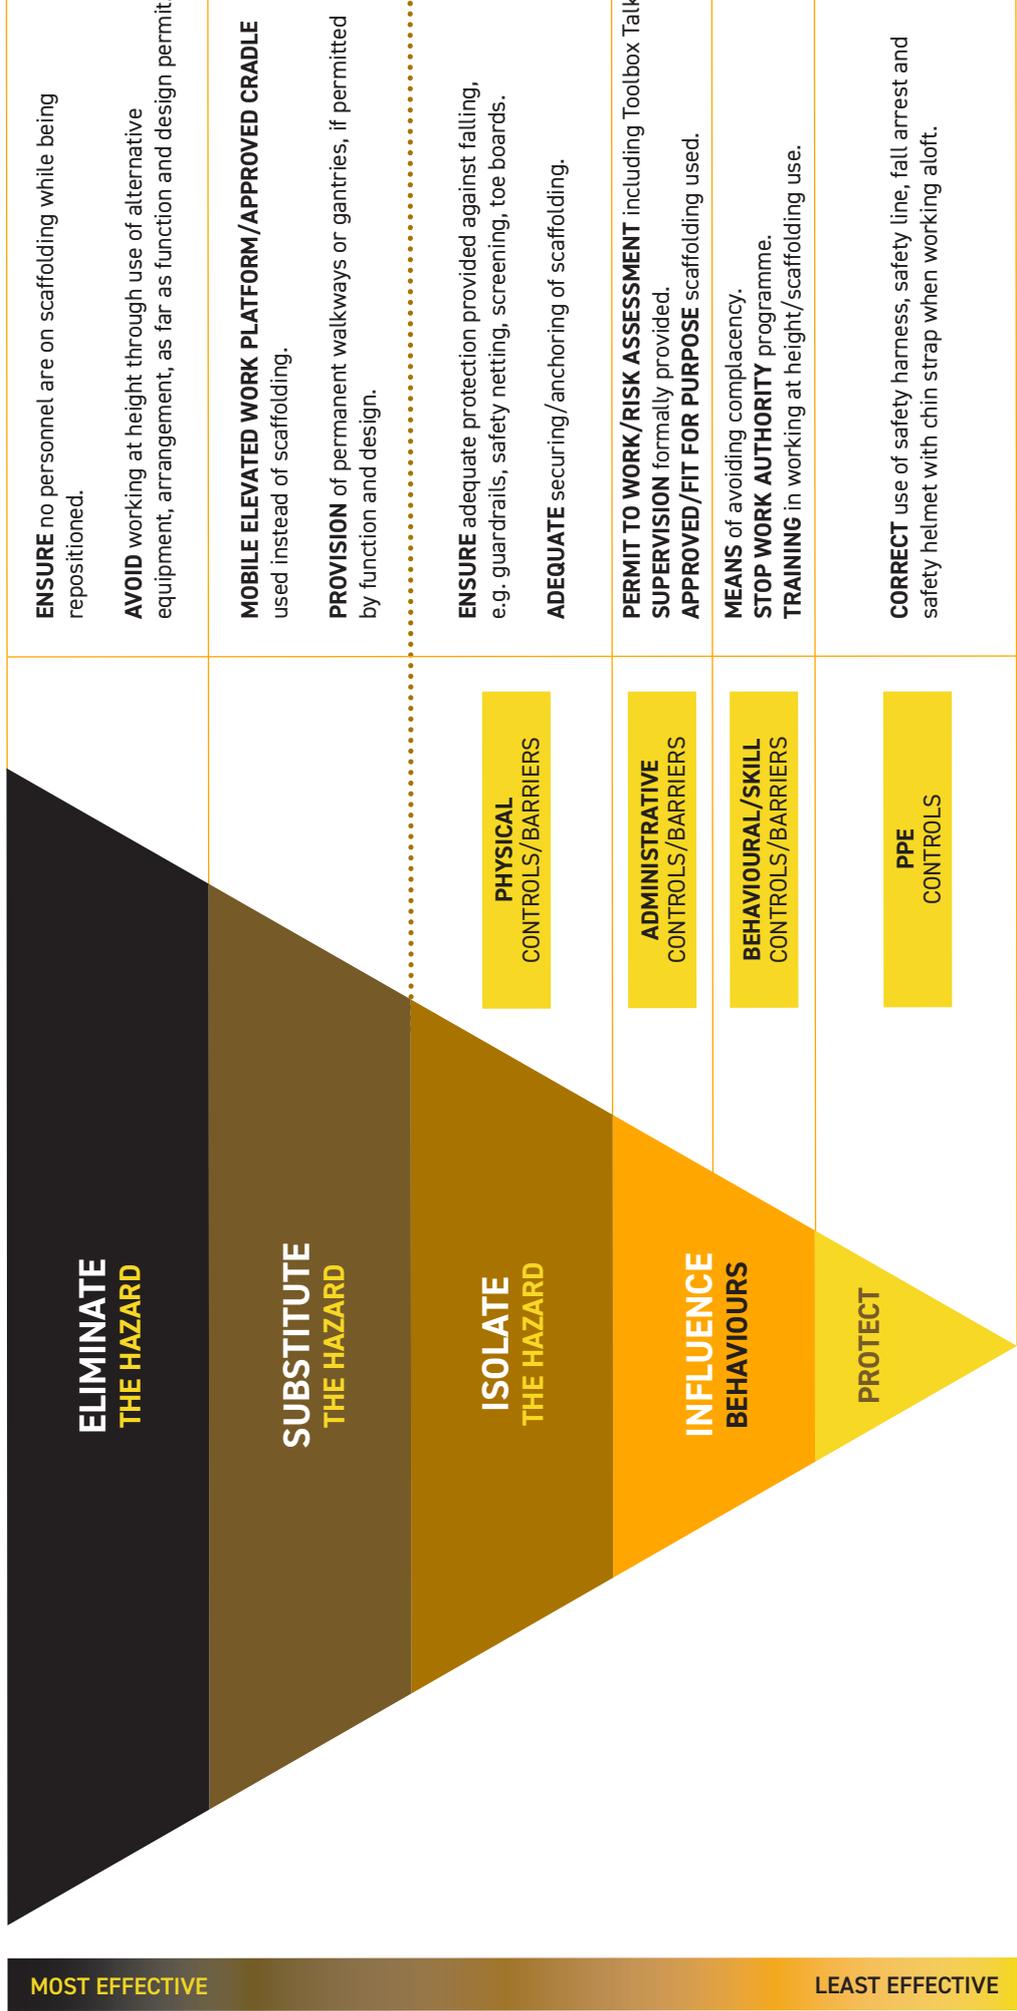
## HIERARCHY OF BARRIER CONTROLS

The first four pages of this commentary discuss some of the contributory factors and lessons learned in more detail with particular reference to best practices. The final page illustrates graphically some of the barrier control measures that could have potentially mitigated against the risks associated with the hazards using Britannia's interpretation of the Hierarchy of Barrier Controls triangle as a framework.

MOST EFFECTIVE

LEAST EFFECTIVE
