RISK WATCH

FEBRUARY 2022

BRITANNIA P&I
TRUSTED SINCE 1855

A MESSAGE FROM THE EDITOR

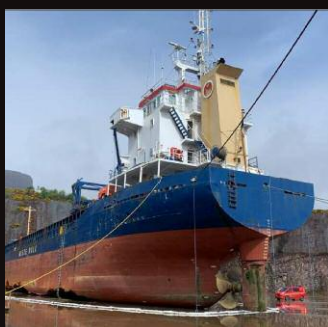
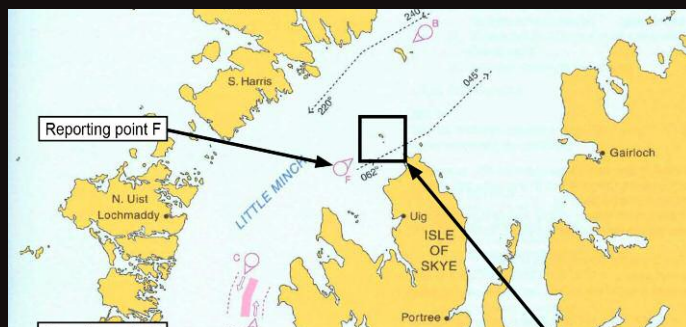
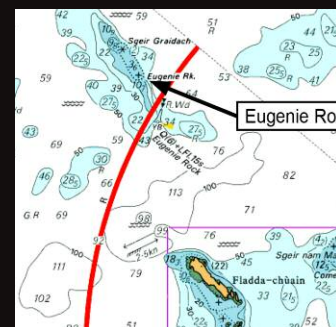
EOW-20-03-23-11-03-26Z_10004BA9F17E75200000014001B78AC

A GENERAL CARGO VESSEL RAN AGROUND ON SGEIR GRAIDACH SHOAL IN THE LITTLE MINCH ON THE WEST COAST OF SCOTLAND. LUCKILY THE CREW WERE SAFELY EVACUATED FROM THE SHIP BY THE LOCAL COASTGUARD, BUT THE VESSEL SUSTAINED EXTENSIVE DAMAGE AND WAS LATER DECLARED A CONSTRUCTIVE TOTAL LOSS. THE INCIDENT INVESTIGATION REPORT IDENTIFIED A NUMBER OF FACTORS CONTRIBUTING TO THE INCIDENT, WHICH PROVIDE VALUABLE INSIGHTS FOR MEMBERS. THE FACTORS INCLUDE FATIGUE, POOR BRIDGE PROCEDURES AND THE ISSUE OF SAFE MANNING LEVELS.

Shortly after ending the VHF call, in accordance with the passage plan and having reached his next waypoint, the chief officer altered course 10 degrees to starboard. At 0141 two heavy impacts were felt on board and the ship ceased forward motion. Realising that the ship had grounded, the chief officer turned on the deck lights and put the engine telegraph to 'stop'. The ship had grounded on Sgeir Graidach rock, a charted hazard.

- The electronic chart cell covering the IMO recommended route through the northern TSS was not loaded into the ECDIS system and the passage planning had been undertaken using incorrectly scaled ENCs.

- If a safety check of the route been carried out prior to departure (it is not known whether this took place or not) it would have shown up 479 separate errors. A safety check for the leg of grounding alone showed 15 errors, which included 2 hazards (isolated dangers) and the crossing of a safety contour.

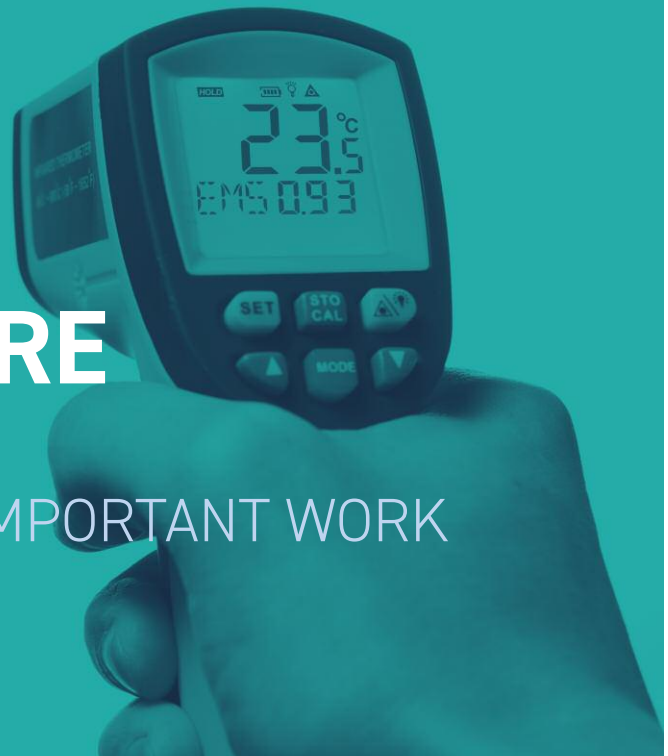
AS MANY READERS WILL KNOW, CARGO TEMPERATURE SENSORS CAN BE A VITAL TOOL FOR ASSESSING THE SUITABILITY OF CERTAIN DRY BULK CARGOES FOR LOADING AND ALSO FOR HELPING TO DETERMINE HOW THE CARGO SHOULD BEST BE CARED FOR WHILST ON THE VESSEL.
