FLOODING OF CARGO HOLDS

THE CLUB HAS SEEN AN INCREASE IN THE NUMBER OF INCIDENTS RELATING TO WATER INGRESS INTO HOLDS, THE CONSEQUENCES OF WHICH CAN PROVE COSTLY AND CAUSE DELAYS TO VESSELS' SCHEDULES. THERE ARE A NUMBER OF WAYS IN WHICH WATER CAN ENTER THE CARGO HOLD OF A VESSEL. THIS ARTICLE WILL FOCUS ON WATER INGRESS FROM CARGO AND BILGE LINES, AS WELL AS BALLAST TANKS. FOR INFORMATION ON WATER INGRESS THROUGH HATCH COVERS, PLEASE SEE THE CLUB'S EXISTING GUIDANCE ON THIS TOPIC.

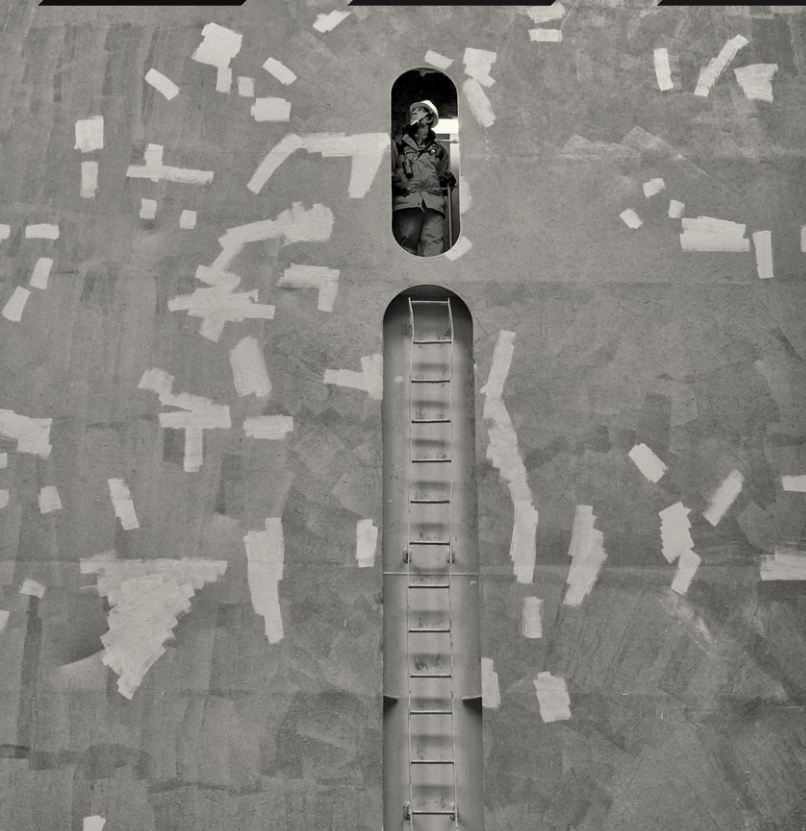
Severe corrosion of ballast tank steelwork may involve plating where localised corrosion is so severe that holes have appeared, or on ballast tank air and sounding pipes in holds

where the blind side of pipework close to the adjacent steelwork has corroded unchecked due to the difficulty of examining this area and removing rust scale. Where inspection of the pipework within a hold is problematic this should be conducted during each dry docking period.
